Department of Veterans Affairs Salt Lake City Health Care System

**700 South 1600 East PCE Plume
AOU-1: East Side Springs
Remedial Investigation Report**

FEBRUARY 2019

Prepared by:
EA Engineering, Science, and Technology, Inc., PBC
2363 N. Hill Field Road, Suite 104
Layton, Utah 84041

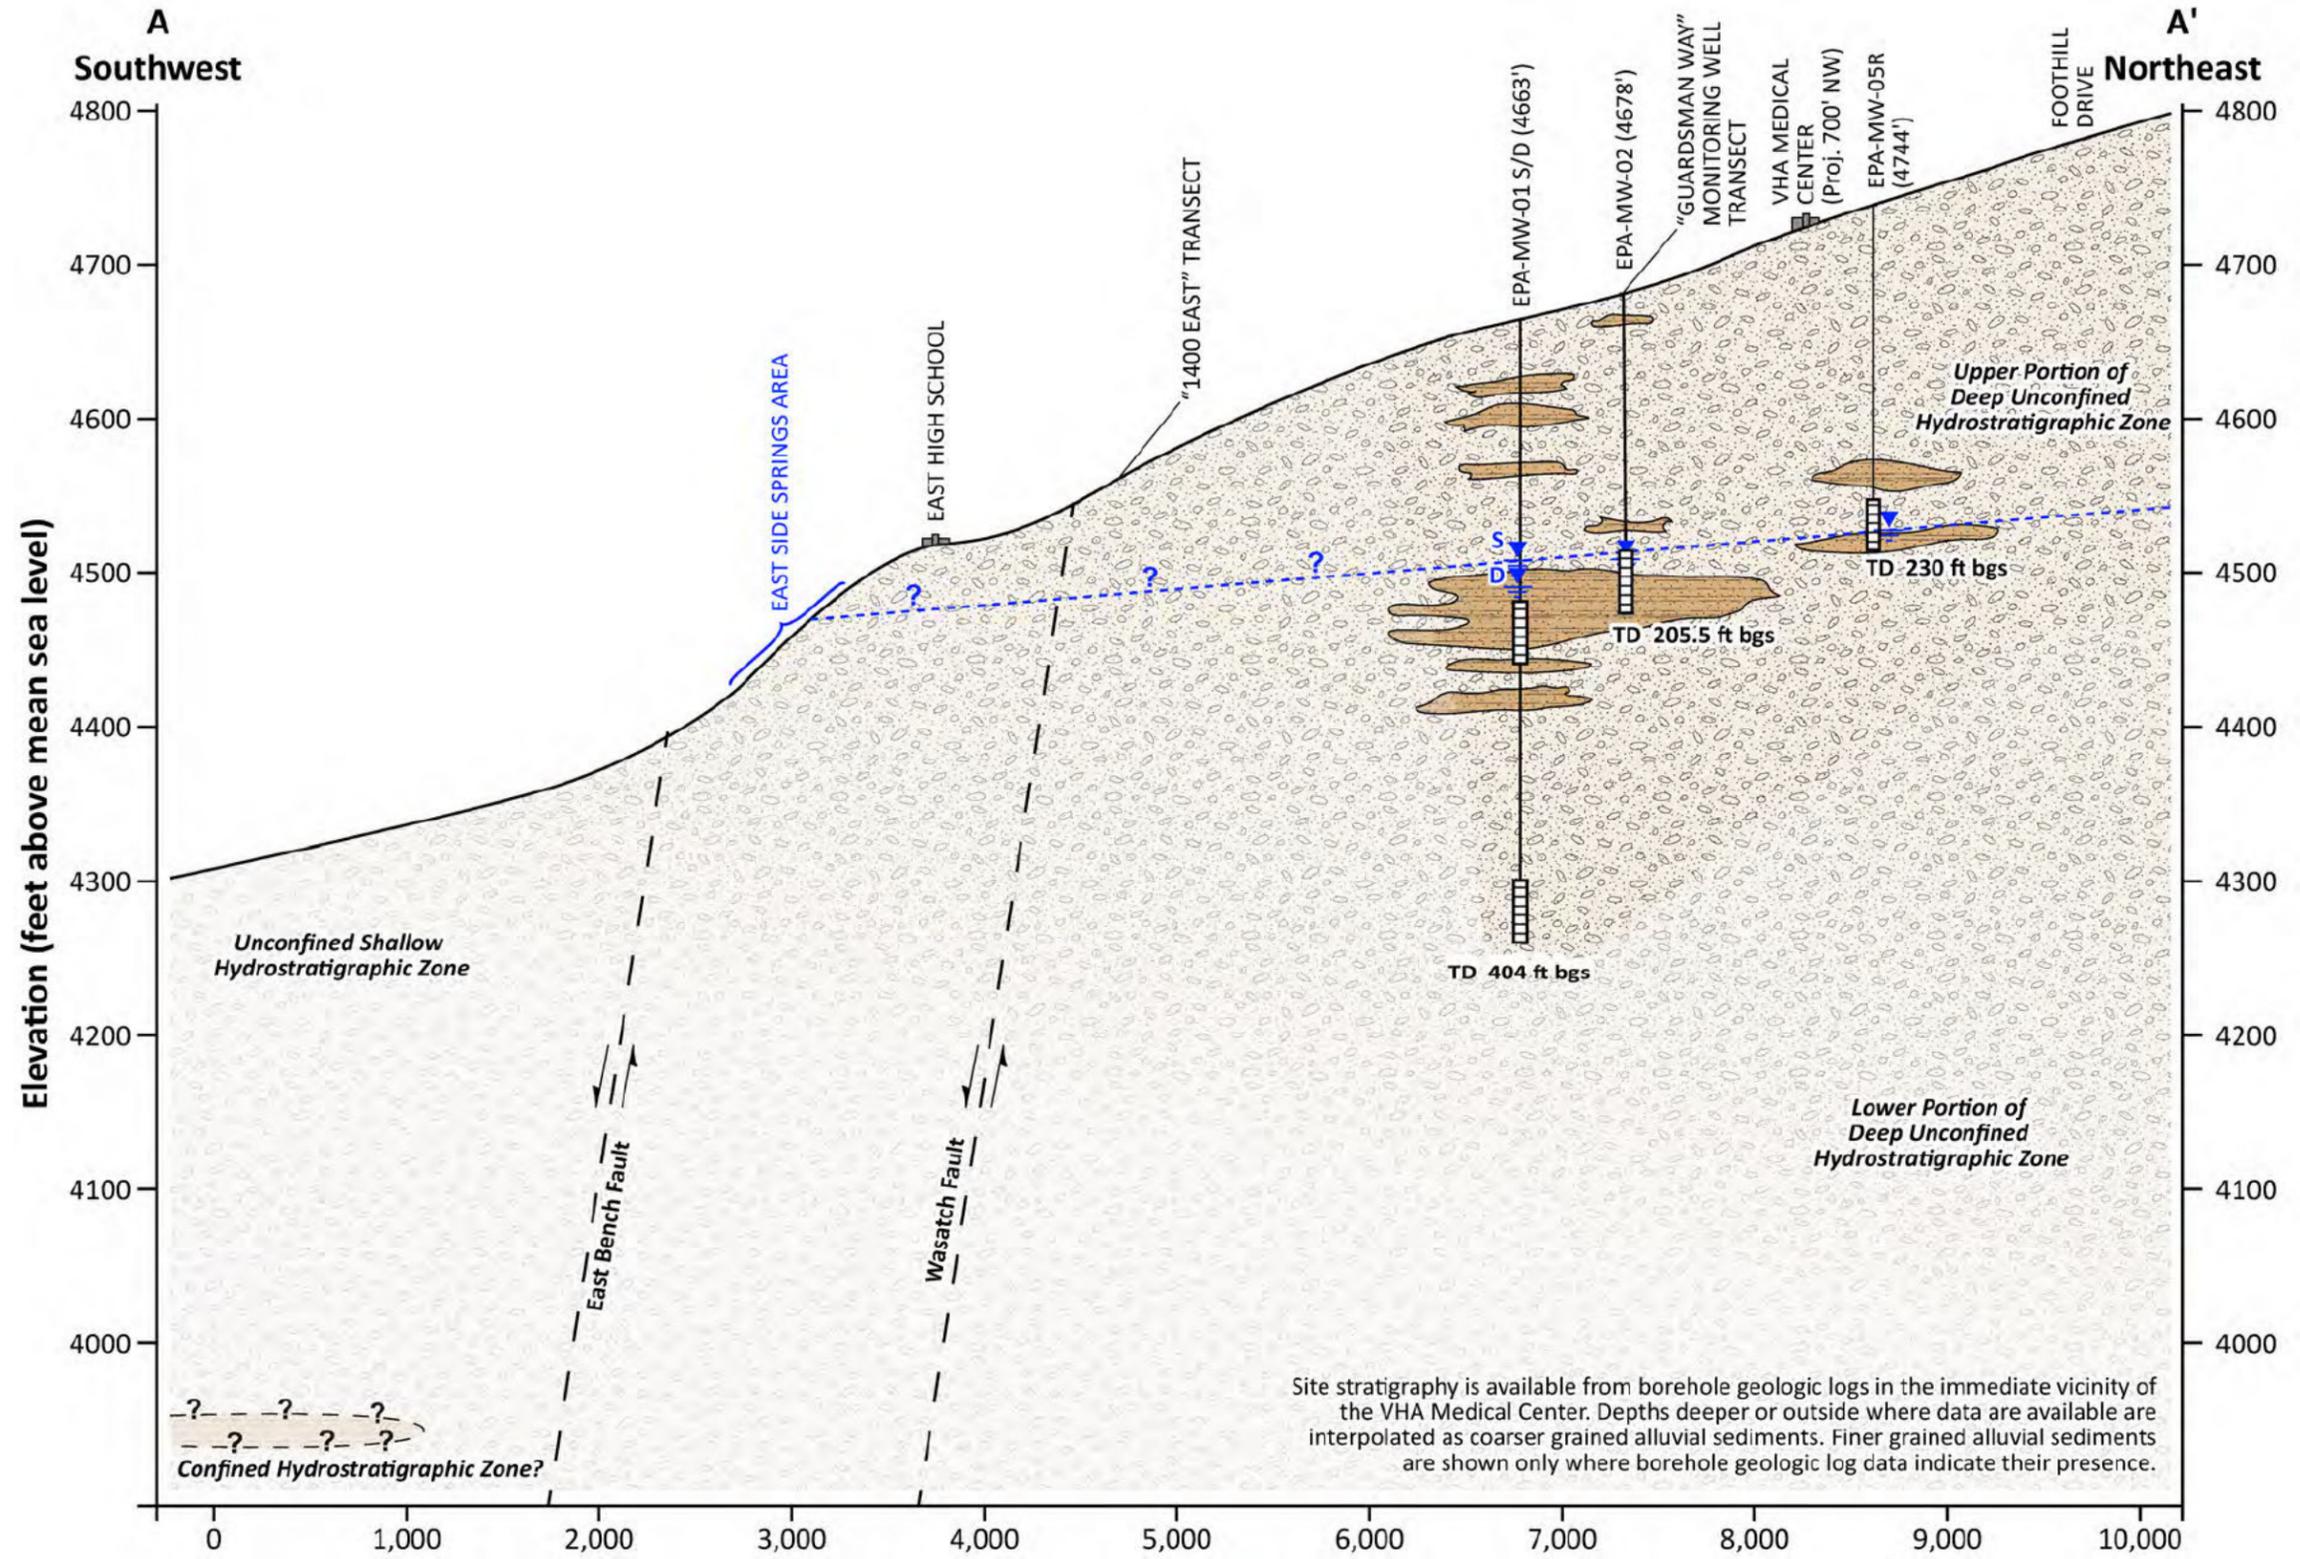
- EPA monitoring well
- Water Level
- Finer grained alluvial sediments classified as clay (CL), gravelly clay (GC), or sandy clay (SC)
- Coarser grained alluvial sediments
- TD = total depth
- ft bgs = feet below ground surface
- ? = Uncertainty
- (4355') = Elevation in feet above mean sea level

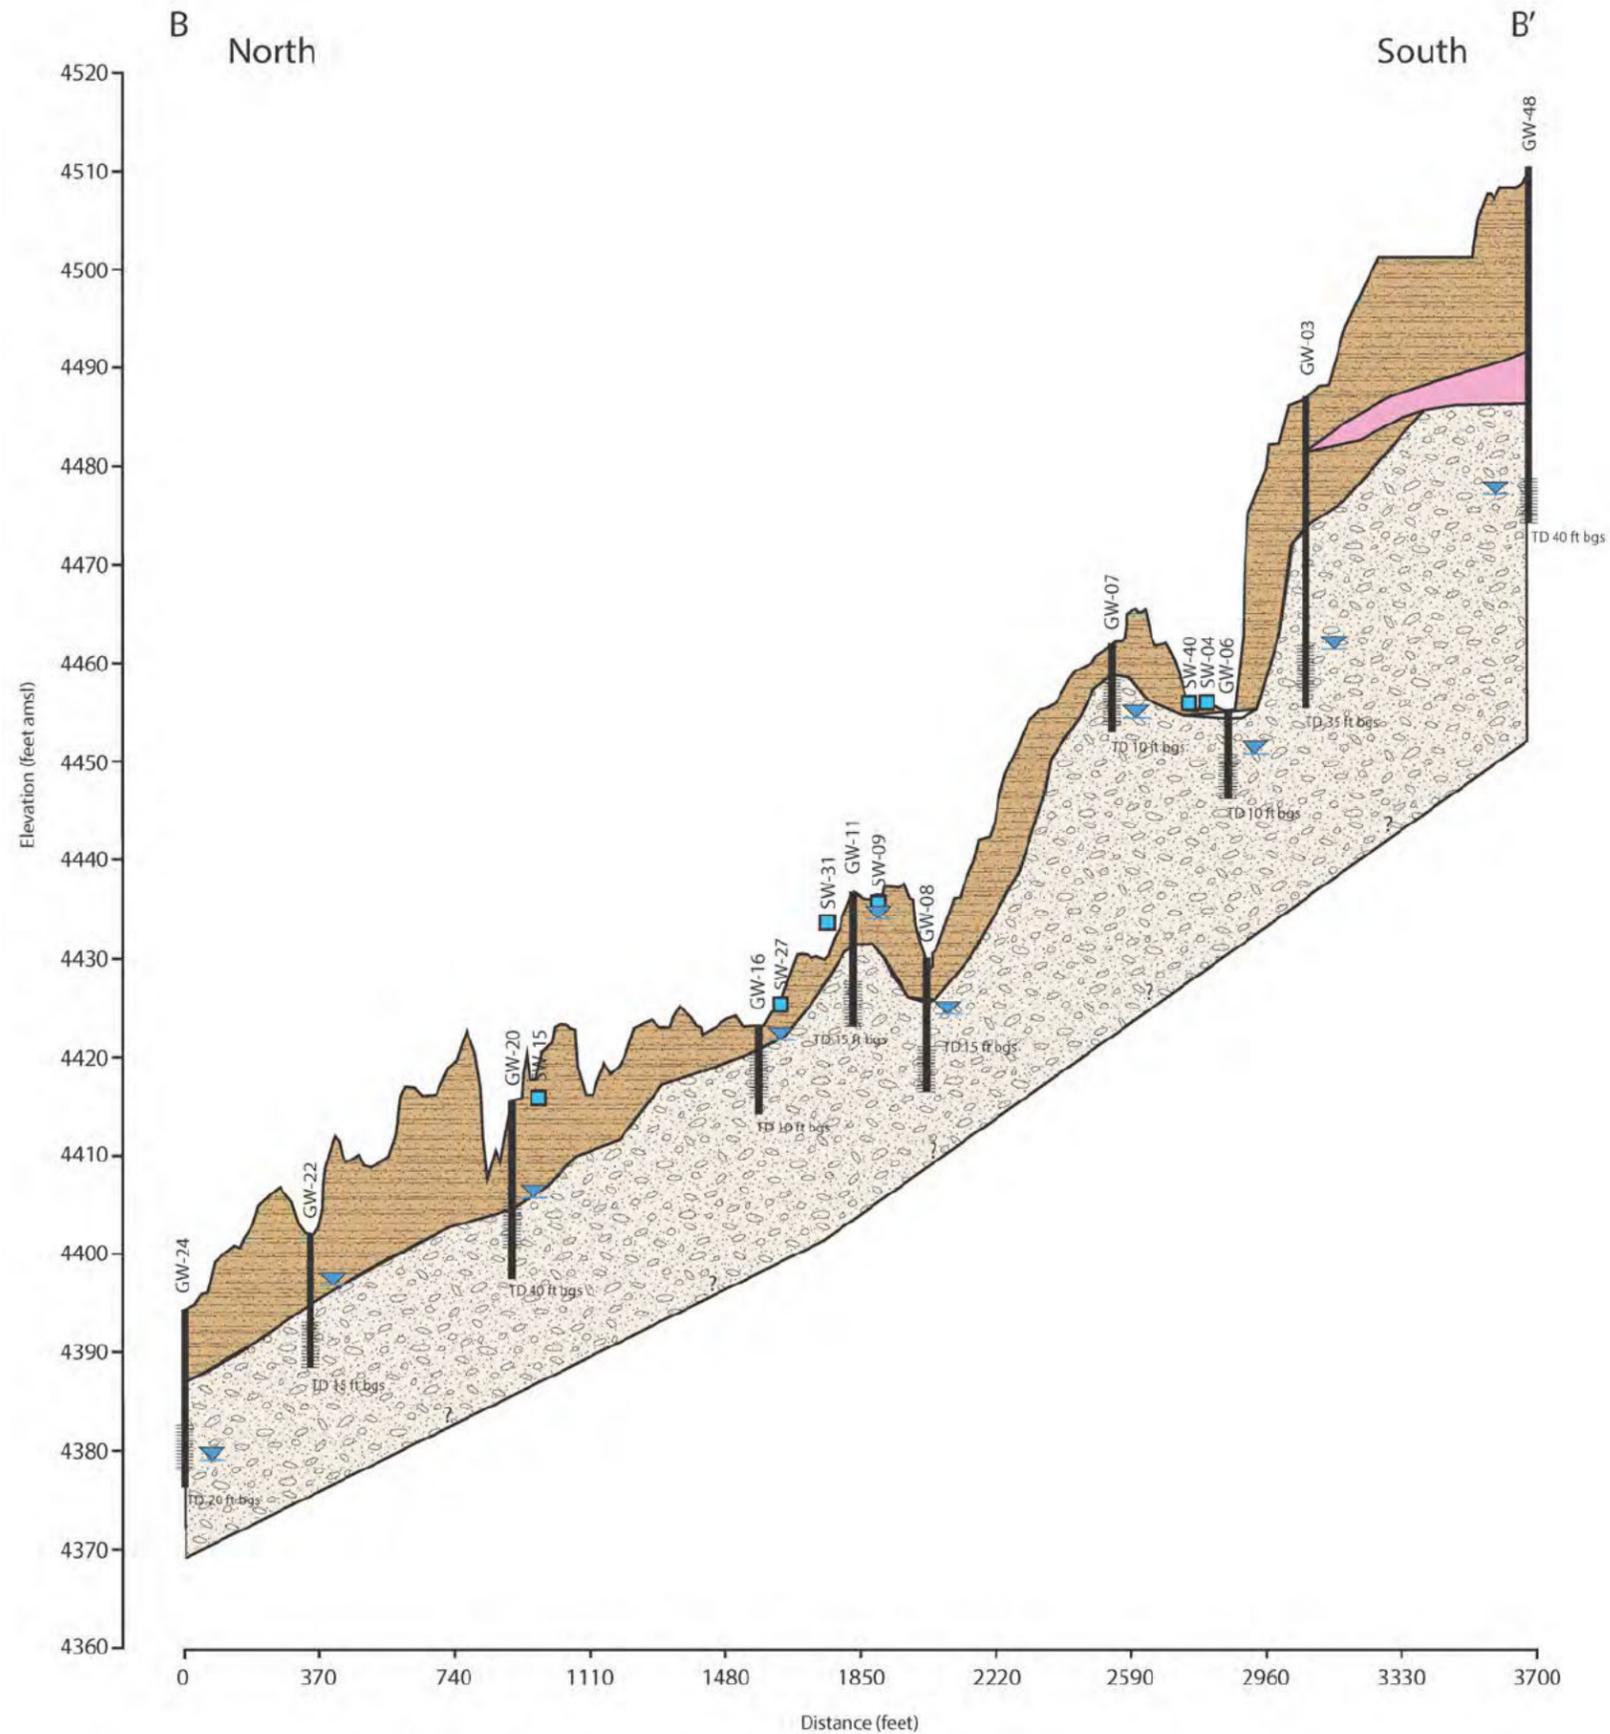
- Surface Water Sample
- ▼ Water Level
- Finer grained alluvial sediments classified as clay (CL), gravelly clay (GC), or sandy clay (SC)
- Coarser grained alluvial sediments
- Pink Clay Deposits: Pink clay horizon found in wells GW-03 and GW-48

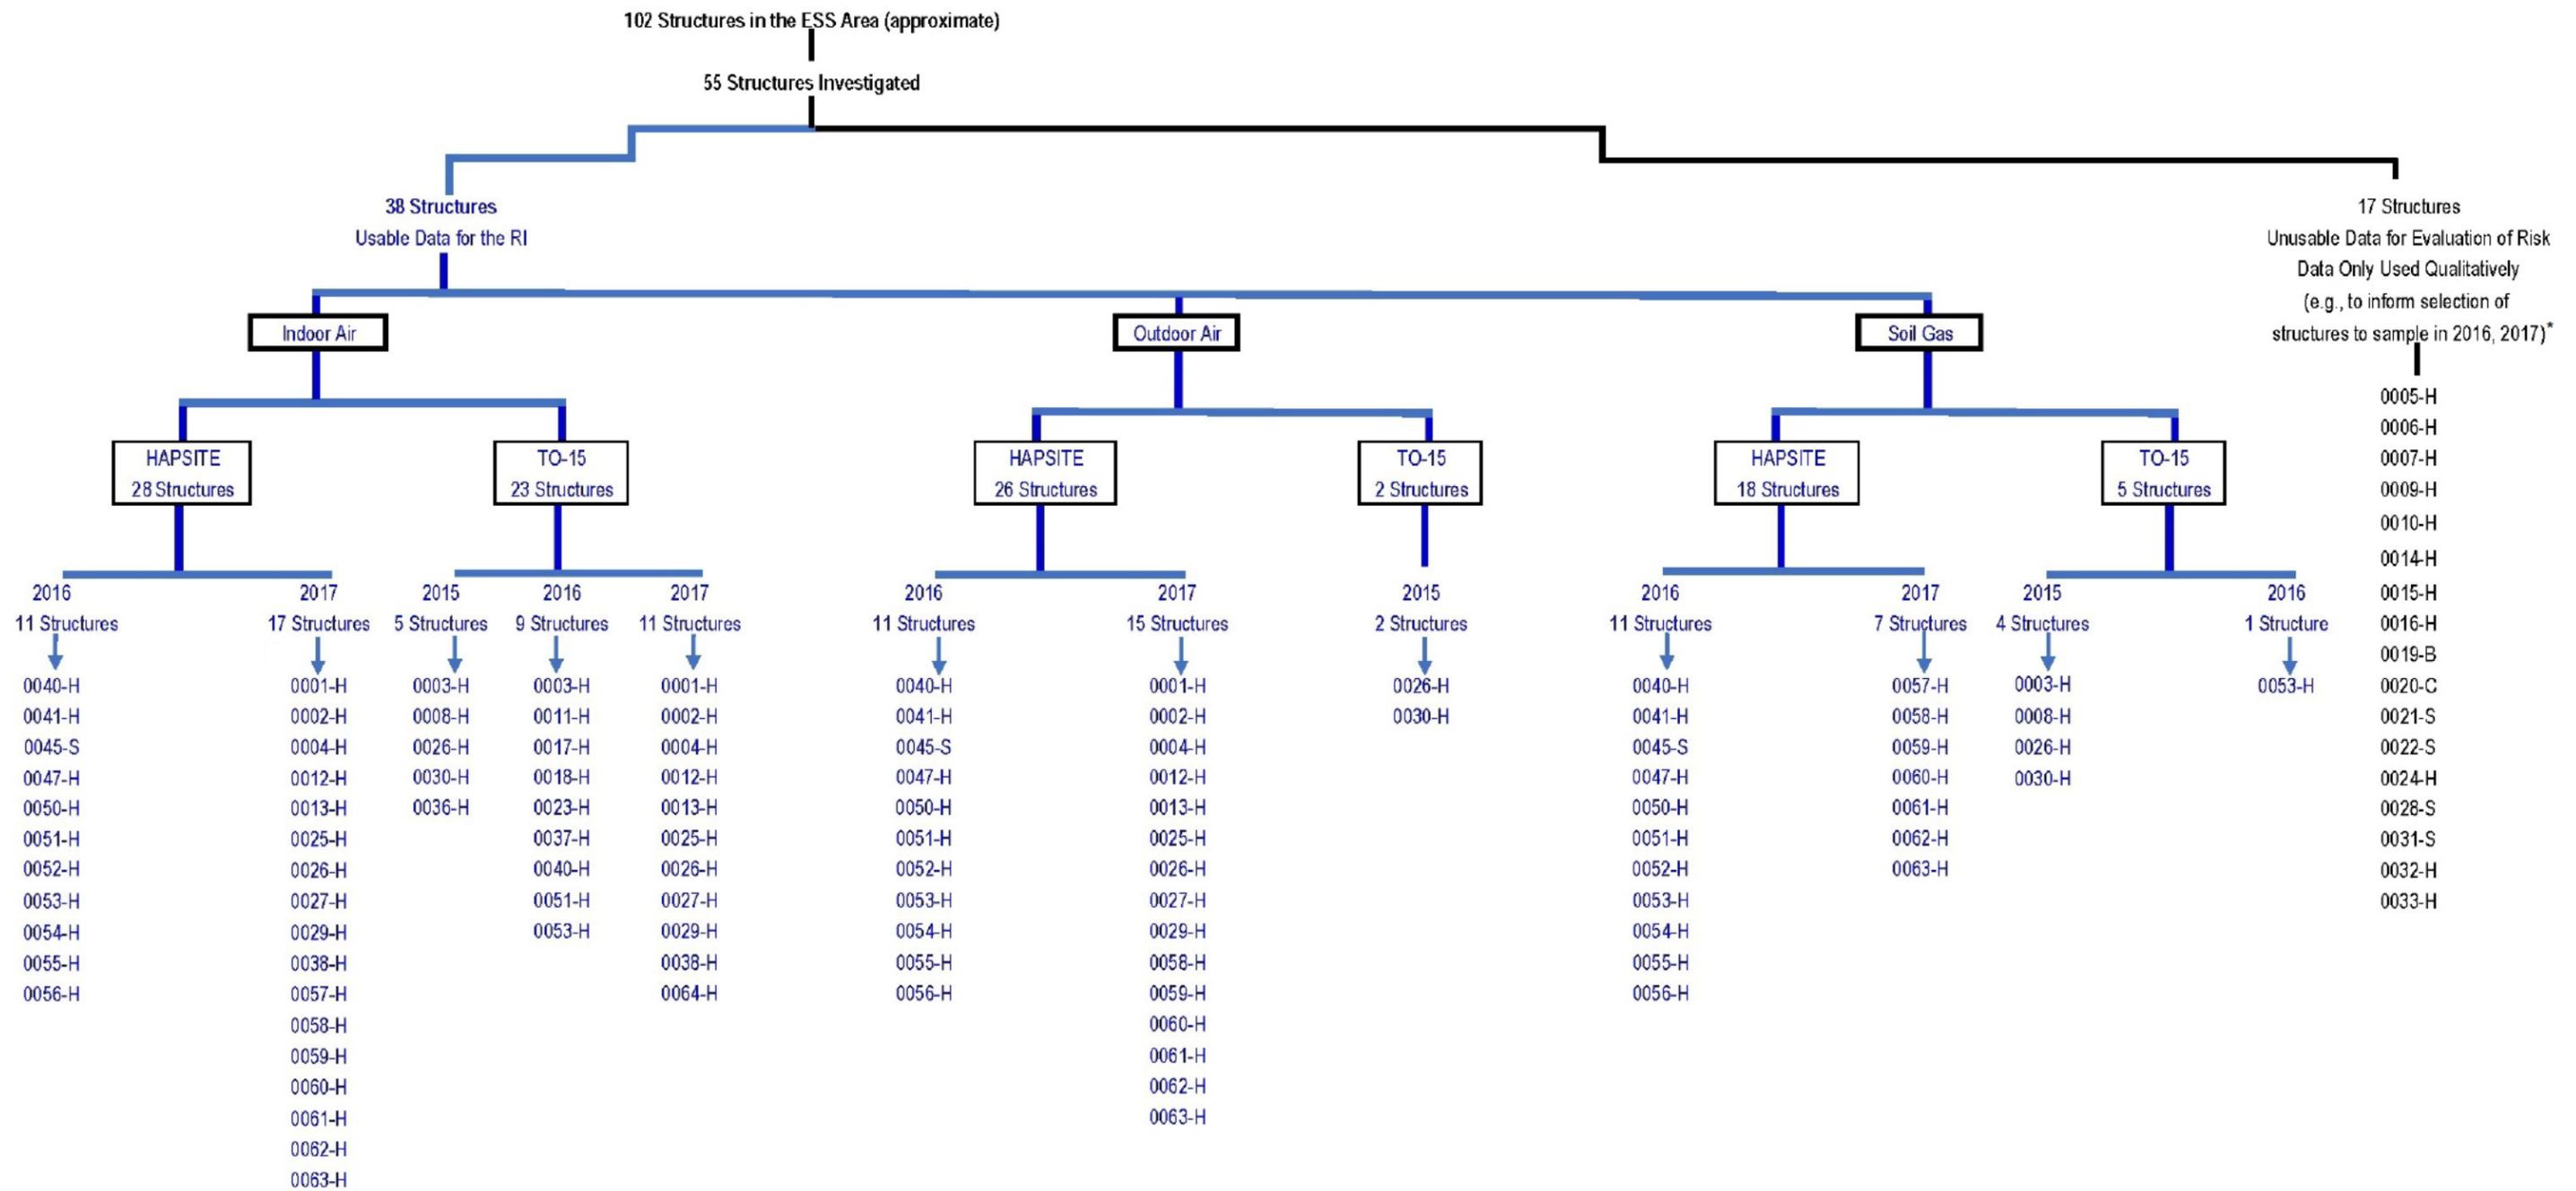
FIGURE 5-4 VI INVESTIGATION STRUCTURES 2015-2017
700 South 1600 East PCE Plume, AOU-1: East Side Springs
Remedial Investigation Report
Salt Lake City, Utah

Note:
* Additionally, 0001H, 0002H, 0004H, 0011H, 0012H, 0013H, 0017H, 0018H, 0023H, 0025H, 0027H, 0029H, 0037H, and 0038H were sampled in 2015, and this data was determined to be unusable. However, these structures were resampled in either 2016 or 2017, and usable data was obtained from these structures for use in the RI.

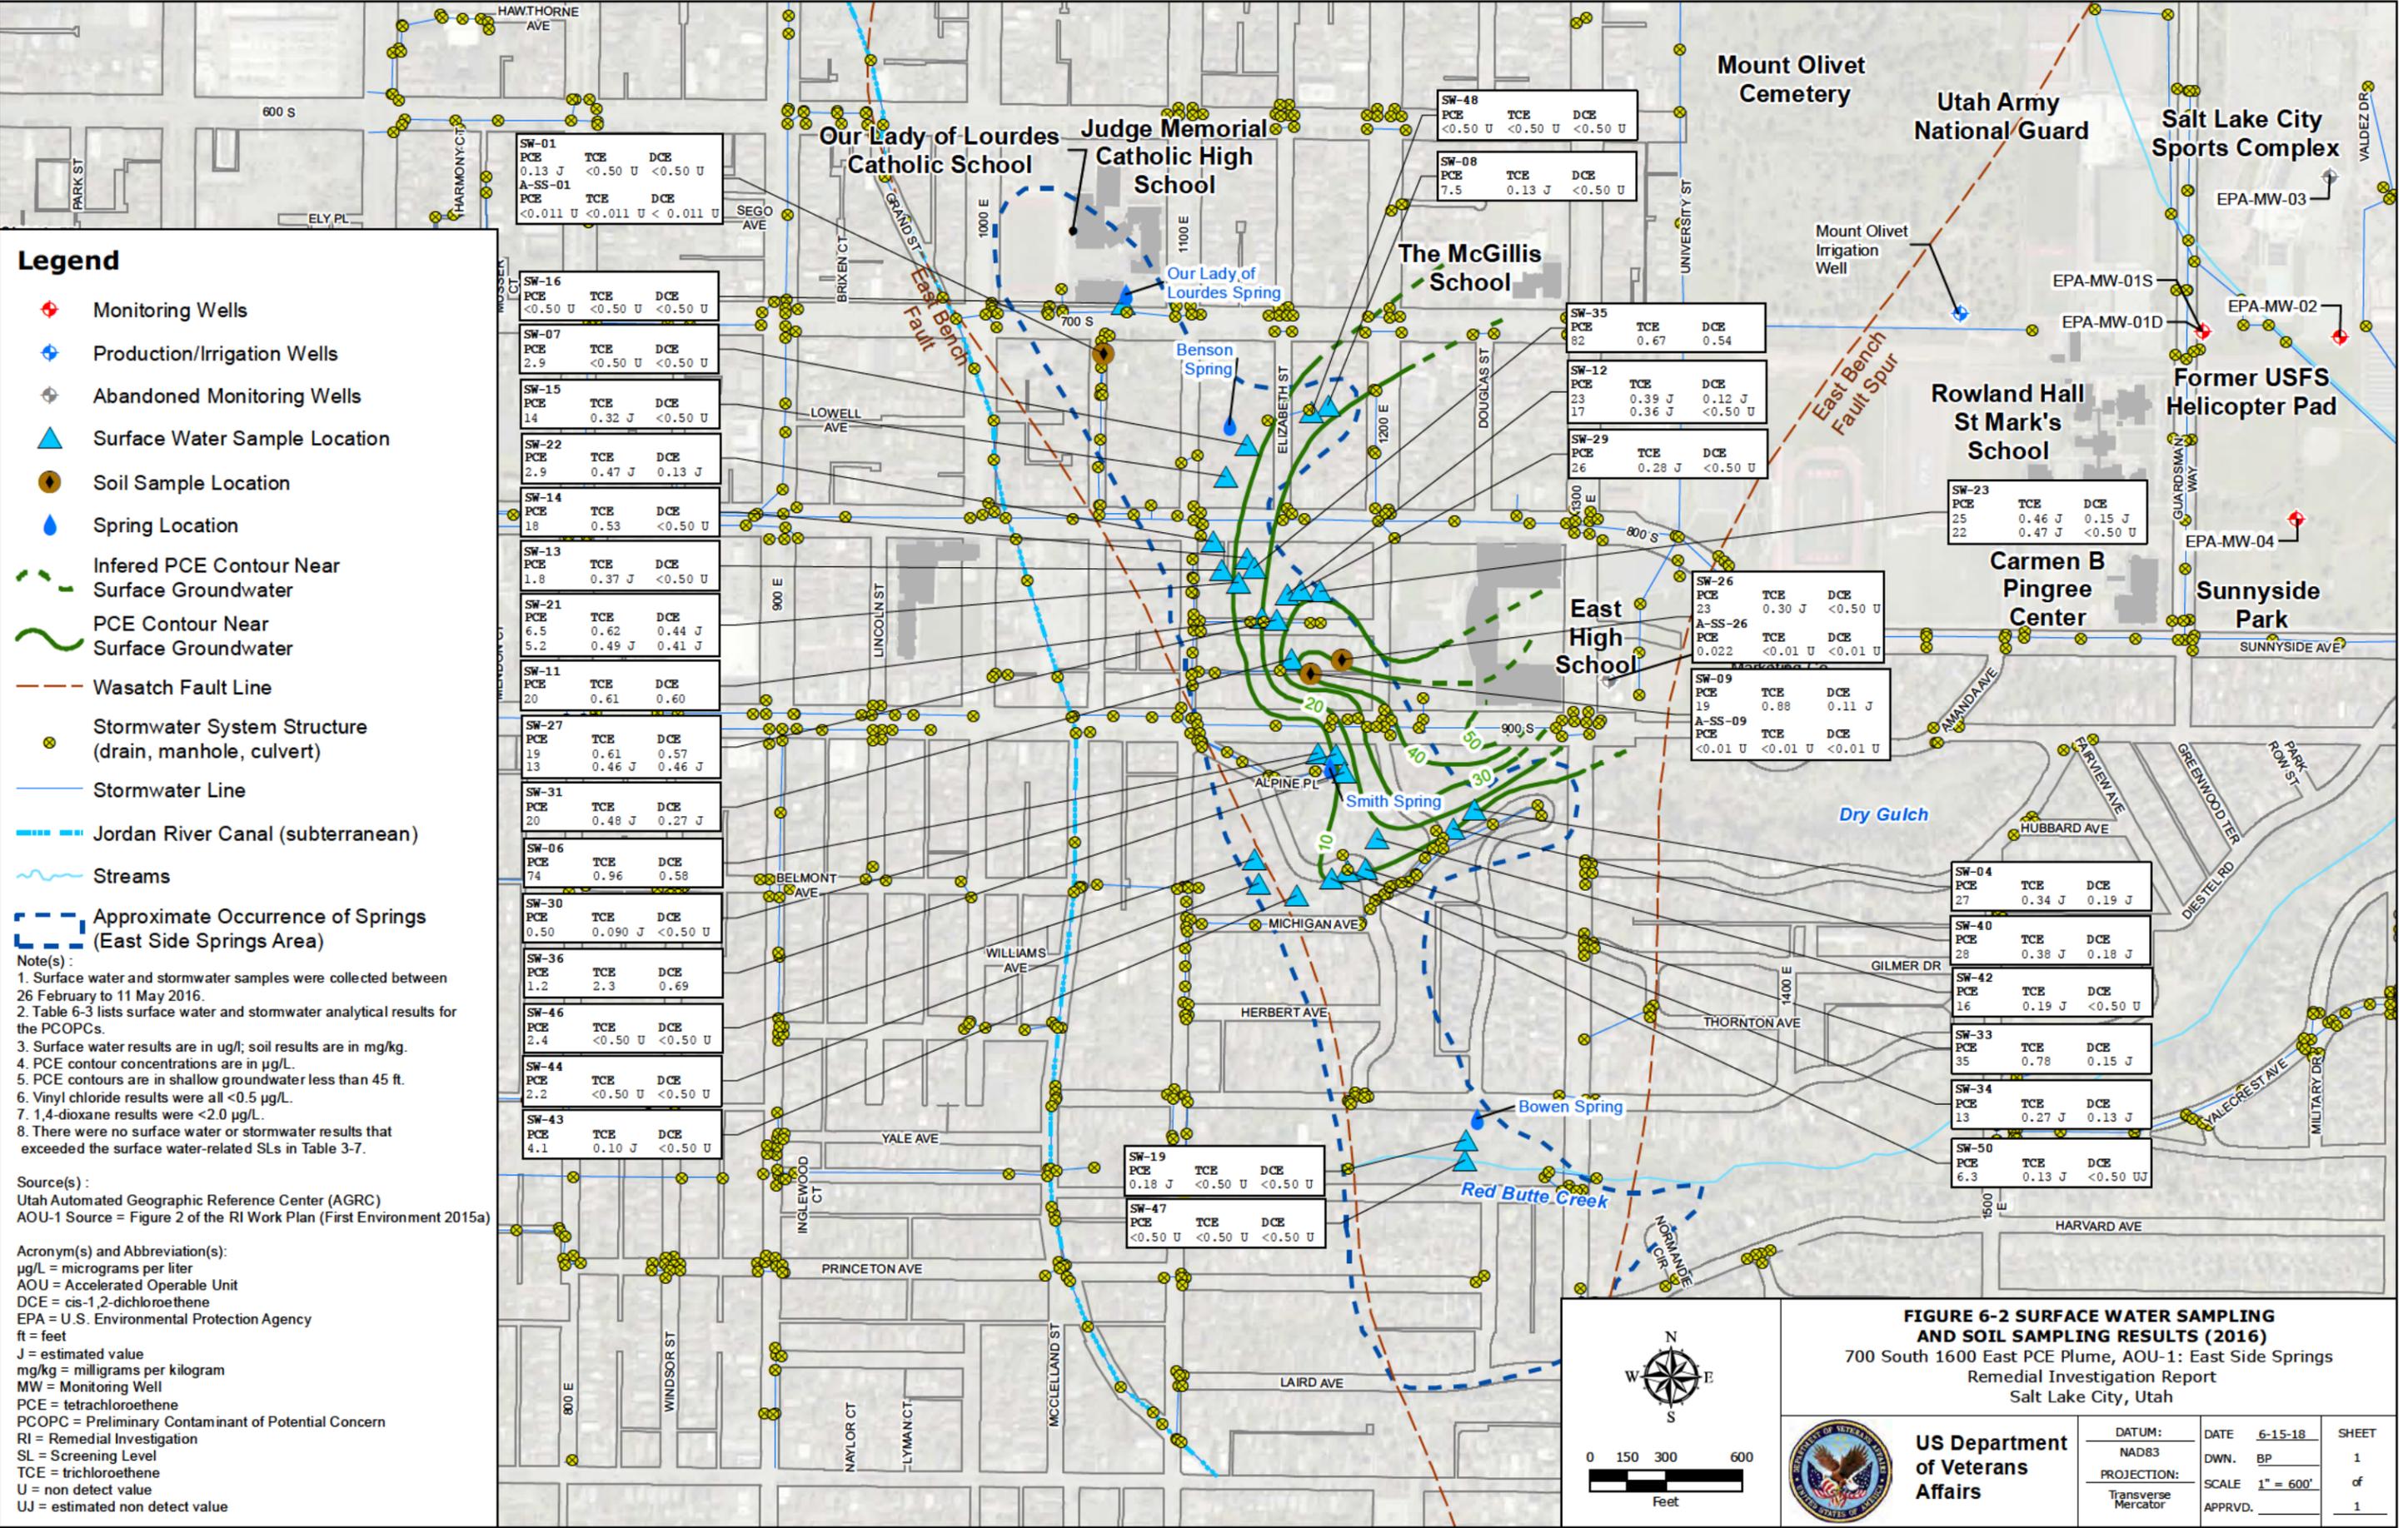
FIGURE 6-2 SURFACE WATER SAMPLING AND SOIL SAMPLING RESULTS (2016)
 700 South 1600 East PCE Plume, AOU-1: East Side Springs Remedial Investigation Report
 Salt Lake City, Utah

Surface water samples were collected from identified and accessible seeps, springs, sumps, and Red Butte Creek to assess the lateral extent of PCOPC contamination. Several of the springs discharge to the municipal storm sewer conveyance system. Therefore, water samples were collected from selected Salt Lake City storm sewer manholes, located in and downgradient of the approximately AOU-1 area, to determine if groundwater seepage and discharge from foundation drains is impacting stormwater. These water samples collected from the storm sewer are referred to herein as stormwater samples; however, the samples were collected during periods of no rainfall (i.e., a minimum of 48 hours after a rain event). Stormwater samples are listed in Table 5-7 and the PCOPC analytical results are provided in Table 6-3. The spatial distribution of the PCOPCs for surface water is presented in Figure 6-2, and stormwater contaminant distribution is presented in Figure 6-3.

There were no surface water or stormwater samples collected specifically as background samples; however, two stormwater samples, SW-10 and SW-24, were collected the furthest up stream of the area of the approximate occurrence of springs (Figure 6-2). Stormwater samples SW-10 and SW-24 were below detection limits for all PCOPCs.

PCE: PCE concentrations in surface water samples ranged from <0.5 µg/L to 82 µg/L. The surface water RBSLs for PCE are 130,000 µg/L and 1,500 µg/L for surface water protection of soil in residential areas, and the ingestion/dermal contact with surface water respectively (Table 3-7). The highest surface water sample PCE concentrations were detected in SW-35 at 82 µg/L and in SW-06 at 74 µg/L. SW-35 is located north of Sunnyside Avenue and south of 800 South in an area where PCE concentrations in very shallow groundwater are estimated to be between 10 and 20 µg/L. It is described as a seep located in a residential back yard. SW-06 is downgradient from the area of highest PCE groundwater concentrations (Figure 6-2) and is described as a subsurface well. The sample was collected from within the shallow well and was not located at the ground surface. It may be potentially more representative of shallow groundwater. All surface water samples had detections of PCE, with the exception of SW-16 (at the northern end of the ESS area, by Our Lady of Lourdes Spring), SW-47 (adjacent to Red Butte Creek), and SW-48 (at the northeastern end of the ESS area). Highest concentrations of PCE in surface water were

Three surface soil samples were collected 3 and 4 May 2016 from the 0 to 0.5-ft interval at locations adjacent to seeps or springs where surface water samples were also collected. Two of the soil samples, A-SS-09 (adjacent to surface water sampling location SW-09) and A-SS-26 (adjacent to SW-26), were collected at locations where shallow groundwater samples exhibited the elevated PCE concentrations along Sunnyside Avenue. The third soil sample, A-SS-01 (adjacent to SW-01), was collected at a location where trace PCE (0.13 µg/L) was detected in the shallow groundwater sample. A summary of the soil sampling PCOPCs results are presented in Table 6-4. The soils sample locations are provided in Figure 6-2.

Three soil samples were collected during the AOU-1 RI (Figure 6-2): two samples near springs where shallow groundwater samples exhibited elevated PCE concentrations, and one in an area where PCE was not detected in the associated shallow groundwater sample. As shown in Table 6-4, the PCOPCs were either not detected or very low (i.e., only PCE was detected in SS-26 at 0.022 mg/kg). As discussed in Section 7.2, the degree of VOC sorption from water to the soils is primarily related to the f_{oc} , which is expected to be low, and percent fines of the soils. Generally, shallow soil in the vadose zone of the ESS area is sandy, with small fractions of silt and clay (Figure 4-3). Consequently, based on the data available from the two soil samples and general characteristics of the soil in the AOU-1 area, it is expected that the PCOPCs do not tend to significantly sorb onto the soils, and, instead, remain mobile in the aqueous phase, or volatilize to the vapor phase, especially where the vadose zone is shallow and soil pore pressure will be near atmospheric pressure.

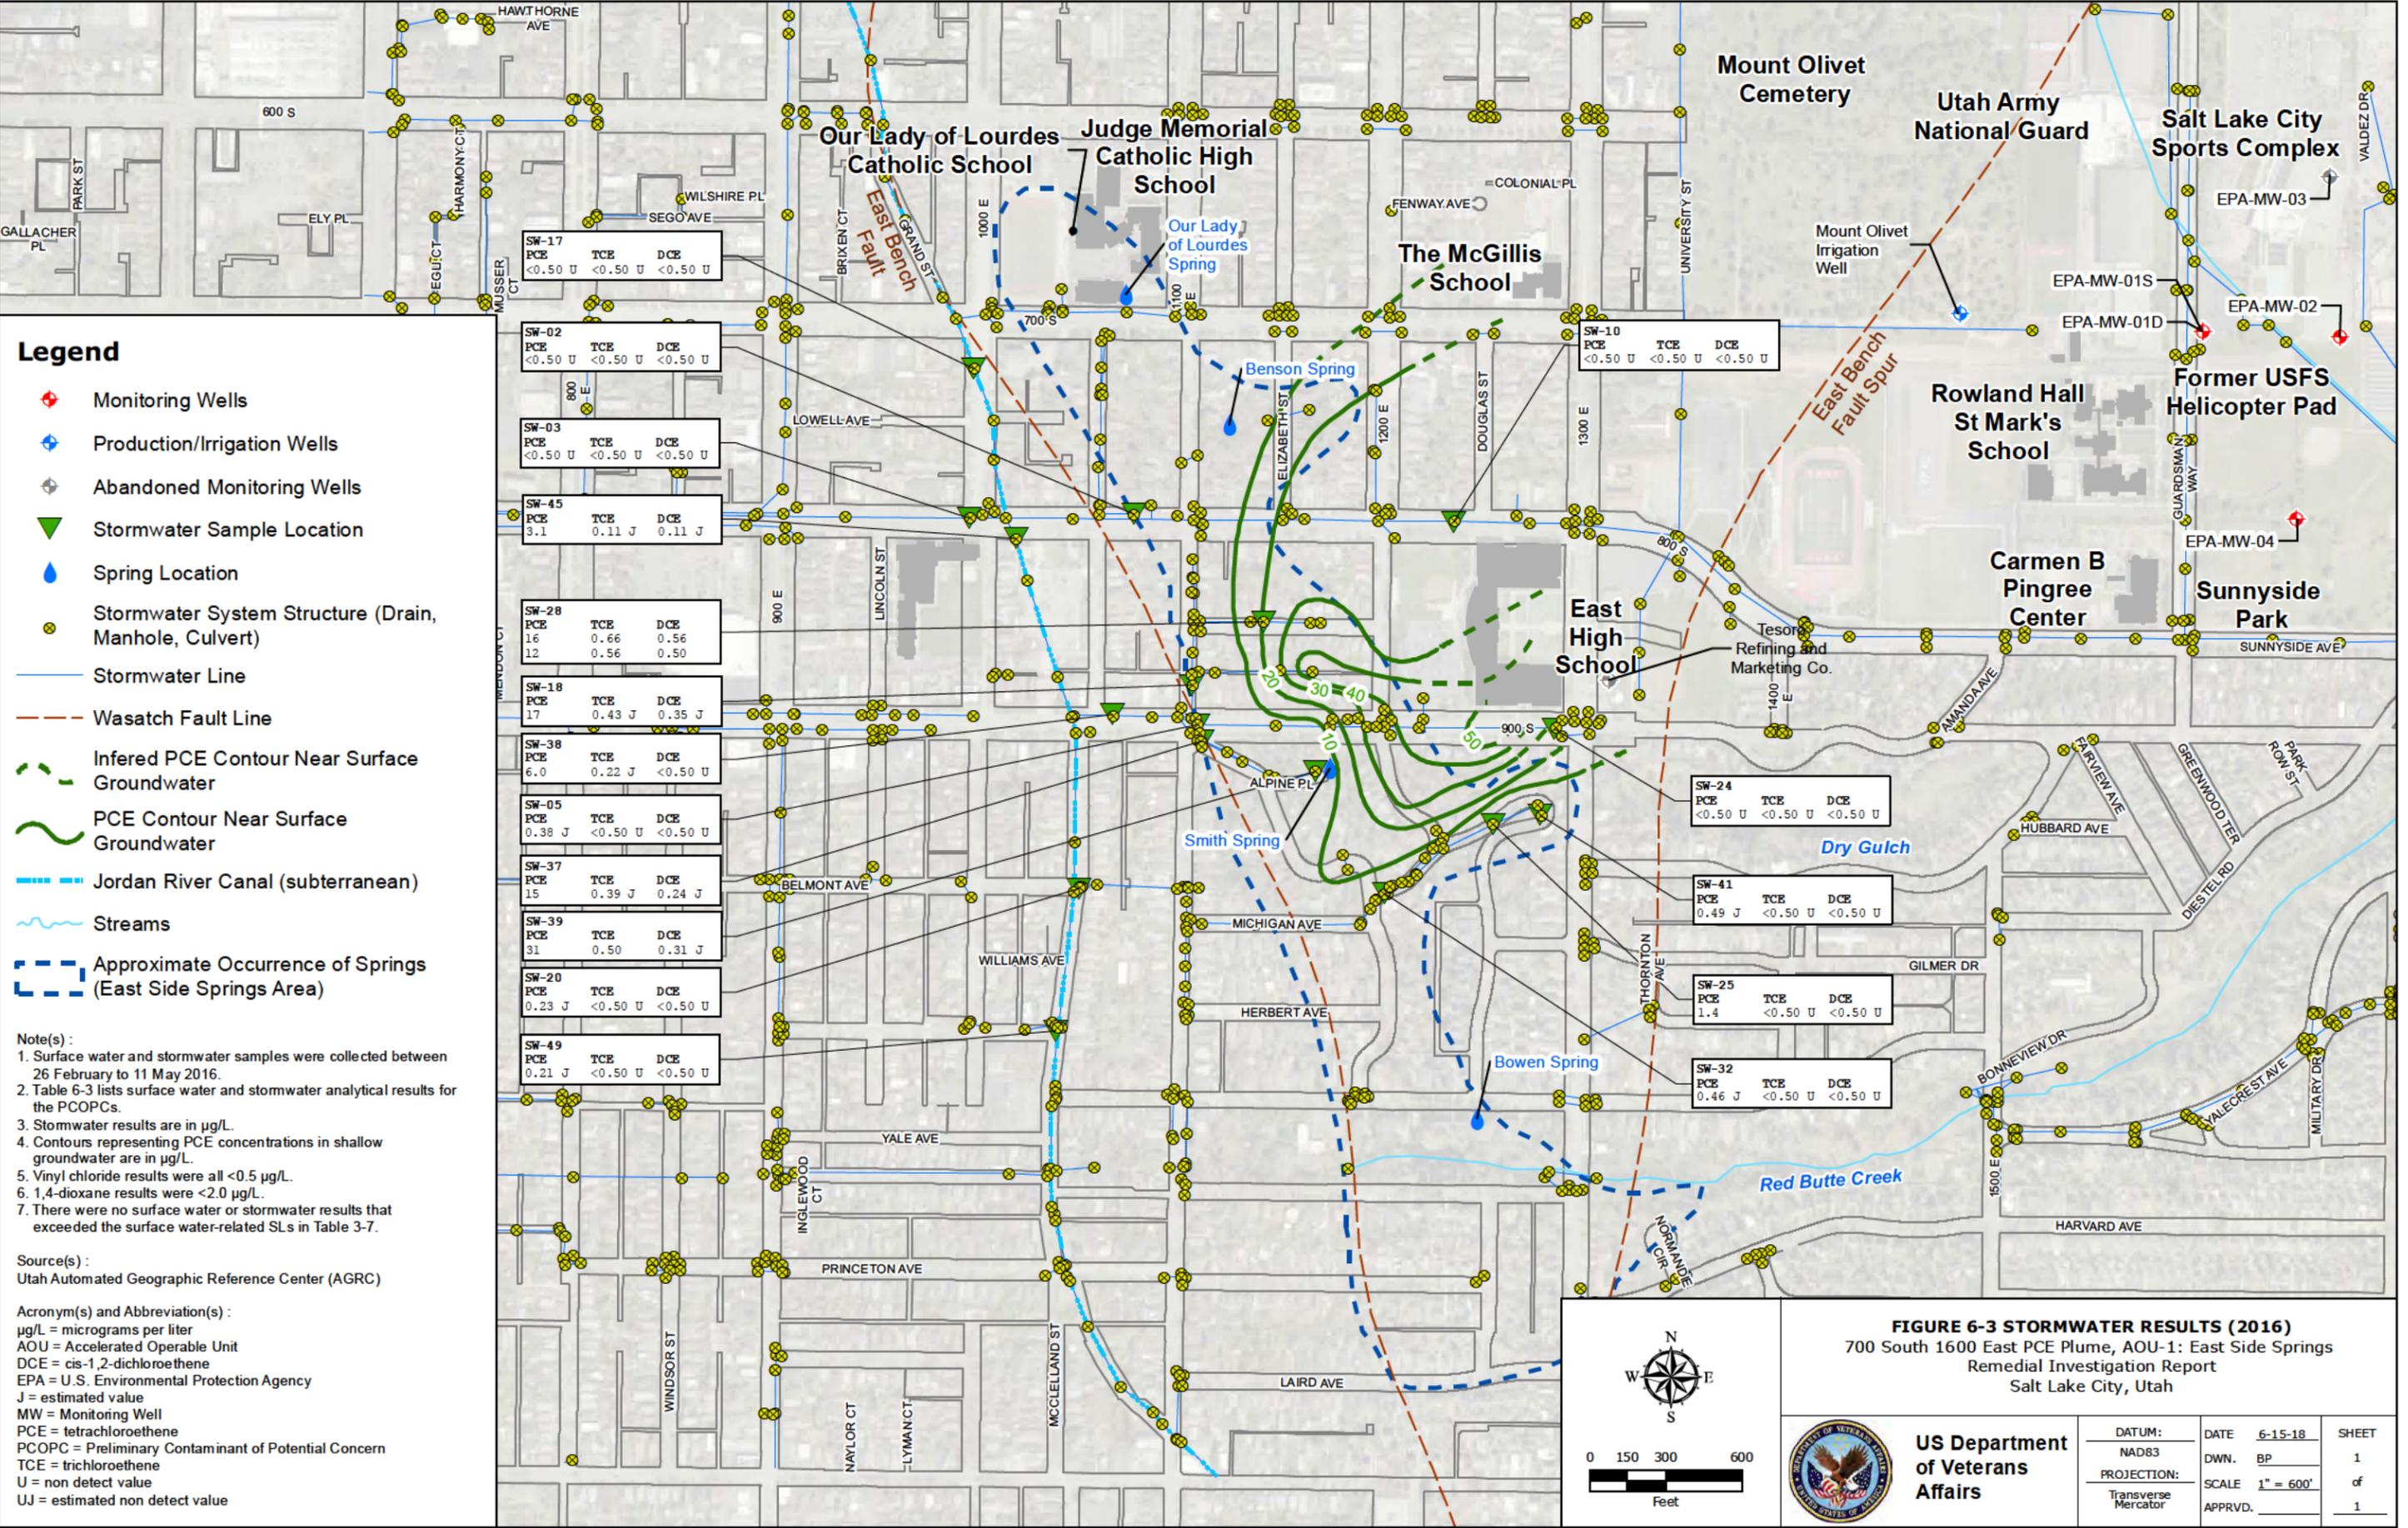
FIGURE 6-3 STORMWATER RESULTS (2016)
 700 South 1600 East PCE Plume, AOU-1: East Side Springs
 Remedial Investigation Report
 Salt Lake City, Utah

The layout of the lines and manholes for the storm sewer are illustrated in Figure 6-3. Generally, the storm sewer system drains from east to west across the ESS area. It includes curbs and gutters, drains, manholes, and culverts. The storm sewer system manages stormwater runoff, but also channels run-off from activities of property owners including residential and commercial irrigation. Some of the seeps and springs in the area have been observed running off into the storm sewer system. In addition, some residents redirect seeps and spring on their property to drain into the storm sewer system. For this reason, some surface water samples were collected from the water (including drainage water) within the storm sewer system. These samples were collected during periods of no rainfall. These samples are listed in Table 5-6 and results are provided in Table 6-3 and illustrated on Figure 6-3.

PCE: Concentration of PCE in storm sewer water samples ranged from <0.5 µg/L to 31 µg/L. The highest concentration of 31 µg/L was found in SW-39, adjacent to Smith Spring, in the center of the ESS area at Alpine Place (Figure 6-3). This storm sewer water sample was also adjacent to surface water sample SW-06, which had the second highest surface water PCE detection (74 µg/L). Storm sewer water samples on both sides of the East Bench Fault contained similar concentrations of PCE.

Samples collected from the storm sewer system (stormwater samples) indicate that the PCE, TCE, and cis-1,2-DCE in surface water and groundwater are being transported to the storm sewer system as water from seeps and springs runs off or is diverted by property owners into the system. PCE, TCE, and cis-1,2-DCE were detected in stormwater samples downstream from seeps and springs (Figure 6-3). Generally, the concentrations detected in stormwater were similar to those detected in the upgradient springs; however, these concentrations are diluted with precipitation and residential irrigation water that enters the storm sewer system. The presence of PCE, TCE, and cis-1,2-DCE concentrations in stormwater, also indicates that the migration pathway to stormwater is complete, similar to the upgradient surface water samples and subsequently the upgradient groundwater concentration in the same area.

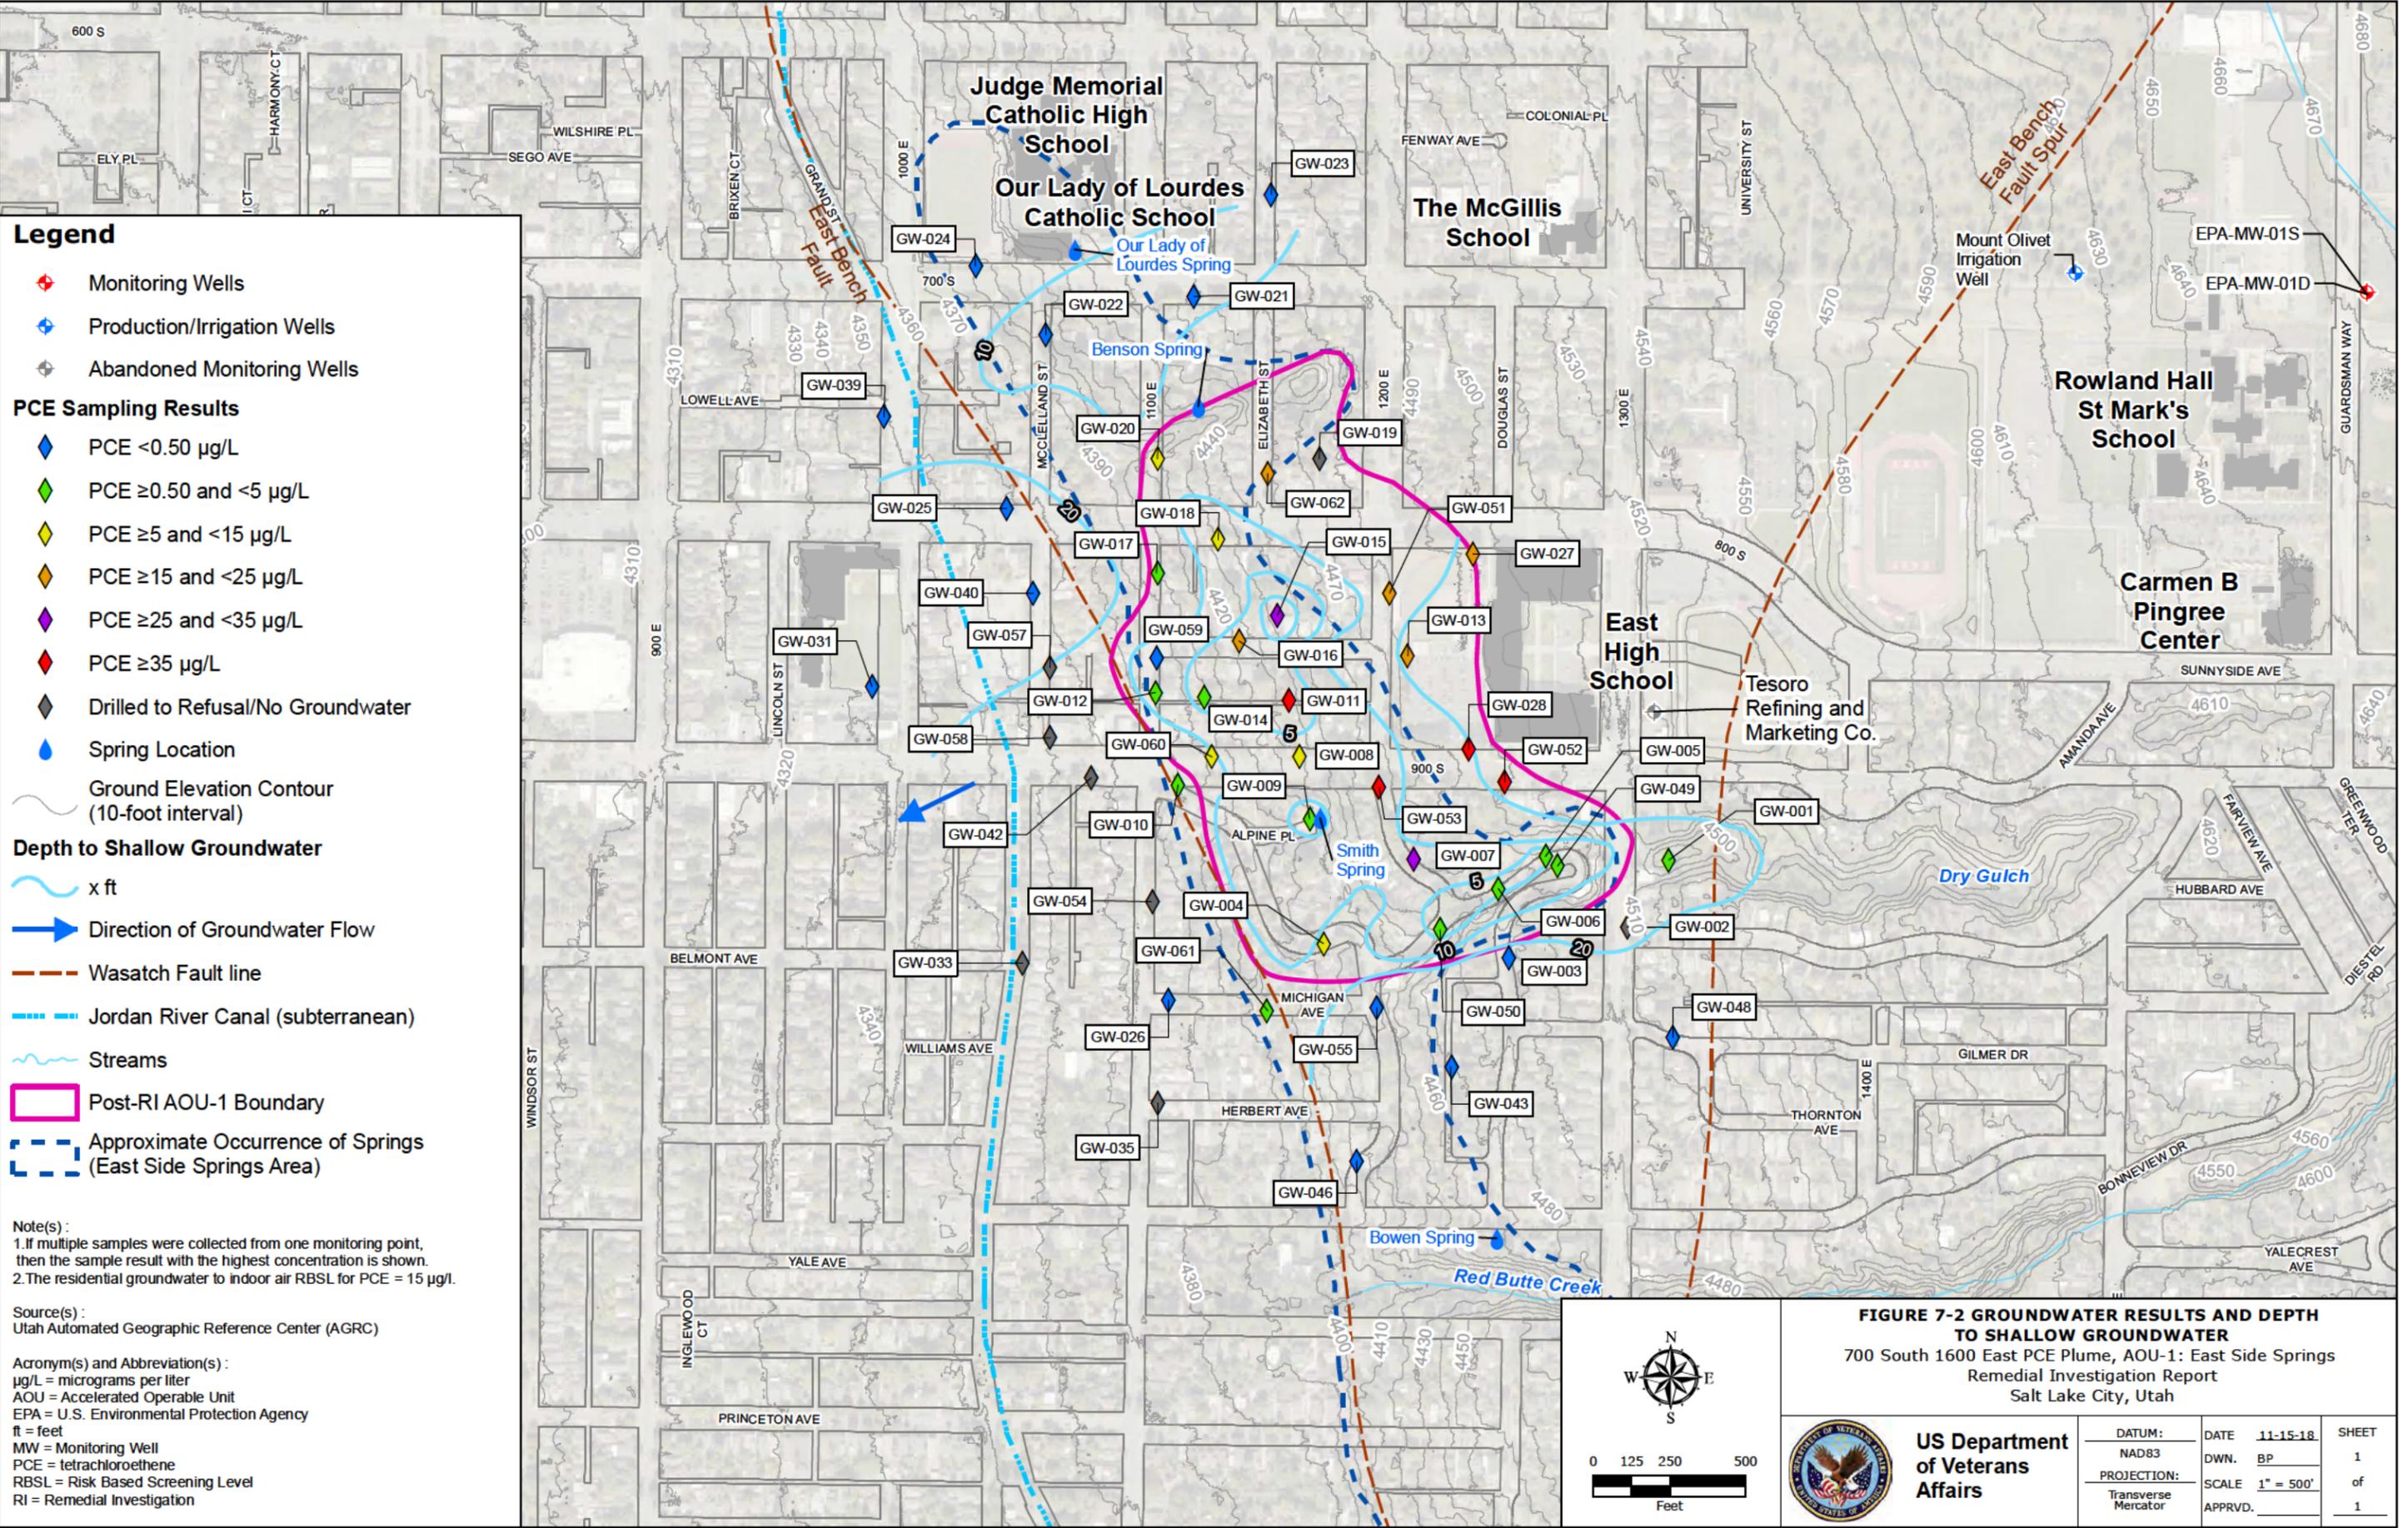
FIGURE 7-2 GROUNDWATER RESULTS AND DEPTH TO SHALLOW GROUNDWATER
 700 South 1600 East PCE Plume, AOU-1: East Side Springs
 Remedial Investigation Report
 Salt Lake City, Utah

When groundwater VOC concentrations are high, and groundwater is close to the surface, there is an elevated risk for VI. There is less soil storage, shorter travel time, and higher vapor concentration in these areas. Figure 7-2 illustrates the general the groundwater concentrations of PCE in relation to depth to groundwater and topography.
