# **Department of Veterans Affairs Salt Lake City Health Care System**

**700 South 1600 East PCE Plume  
AOU-1: East Side Springs  
Remedial Investigation Report**

**Sections 1-11**

**FEBRUARY 2019**

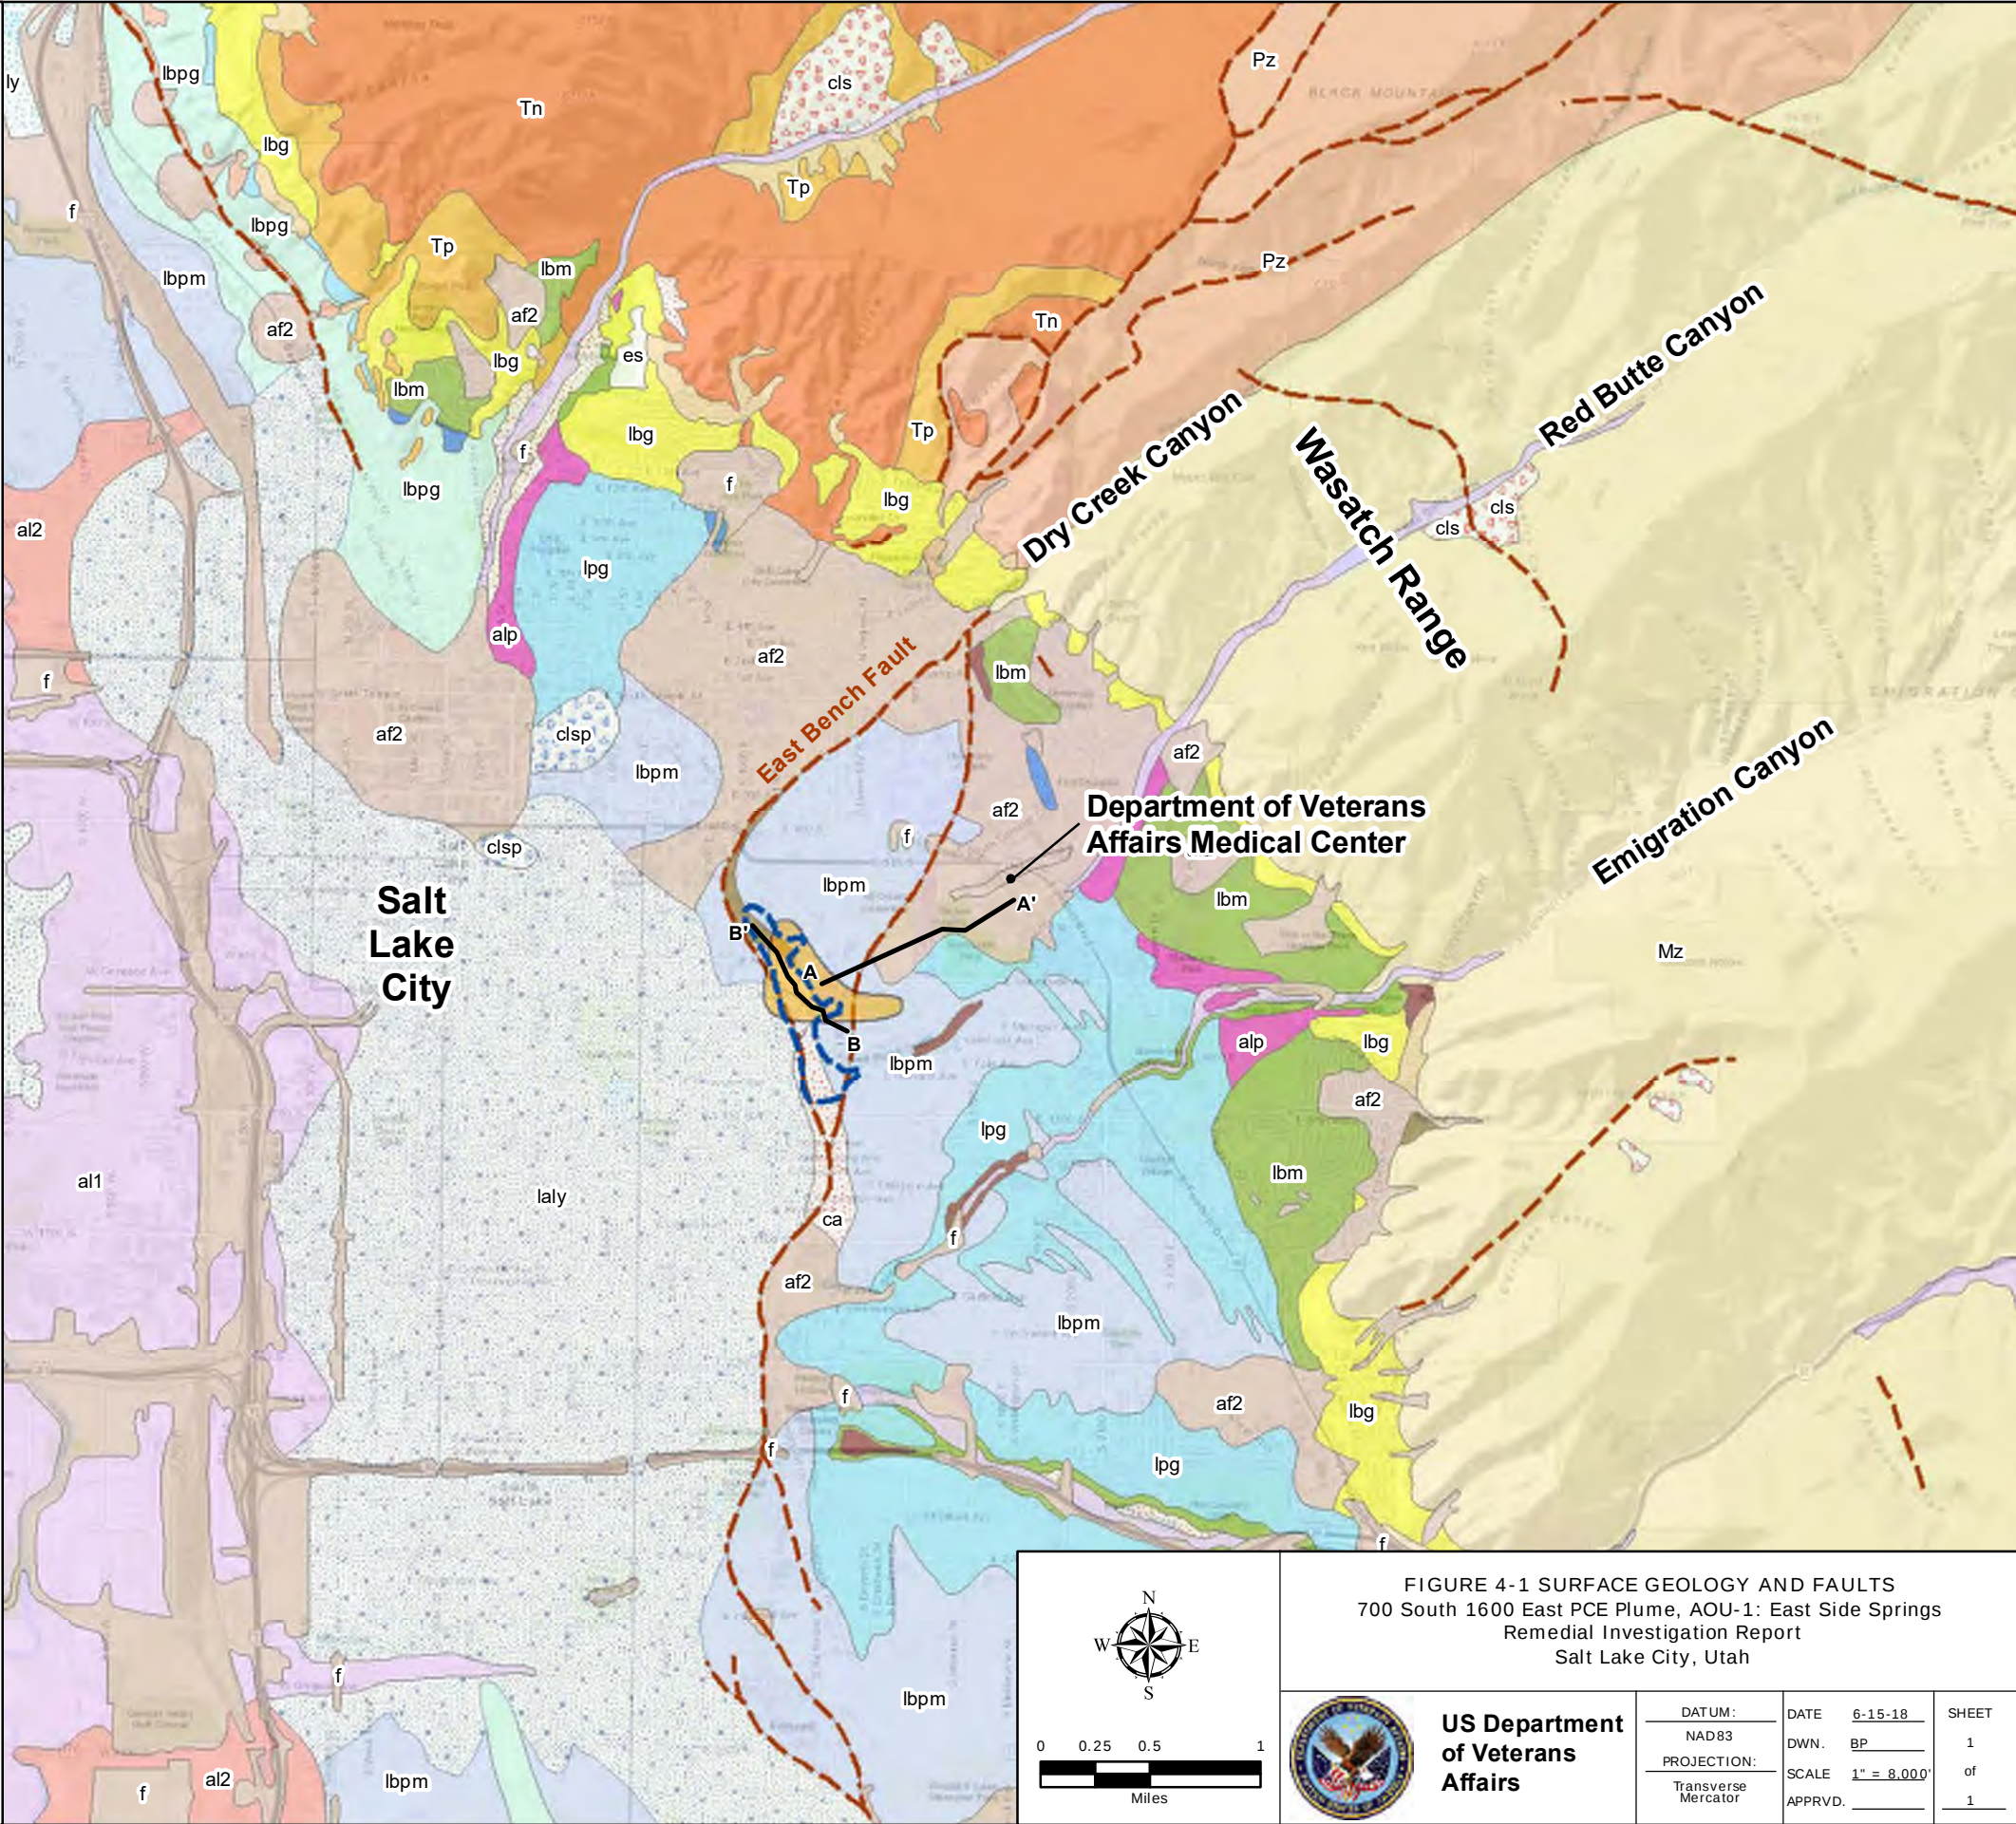
FIGURE 4-1 SURFACE GEOLOGY AND FAULTS  
700 South 1600 East PCE Plume, AOU-1: East Side Springs  
Remedial Investigation Report  
Salt Lake City, Utah

The surficial geology is comprised of the unconsolidated Quaternary-era deposits that formed as alluvial fans by streams as deltas and other lacustrine features associated with the paleo-lake, Lake Bonneville. The fans slope gently to the southwest. In general, the lacustrine deposits nearest the Wasatch Range to the east are coarser and become finer further into Salt Lake Valley to the west (Personius and Scott 2009). The VAMC sits atop the coarser-grained deposits, with the finer-grained deposits found west of the VAMC (Figure 4-1).

The surficial geology changes from east to west across the Site. Coarse-grained alluvial fan deposits with gravel and sand and silty sand interbeds are found nearest the VAMC. The presence of the coarse-grained materials was confirmed by the boring logs for the EPA monitoring wells installed near the VAMC (UDEQ 2000). The boring logs are provided in Appendix A. These coarse-grained deposits are surrounded by lacustrine deposits to the north, south, and west. The lacustrine deposits become more fine-grained west of the VAMC until the East Bench Fault, which is identified by the presence of mixed colluvium and alluvium deposited as a debris apron at the base of the scarp. The contact for the sediments and the site is assumed to be present at a depth greater than 1,000 ft bgs.

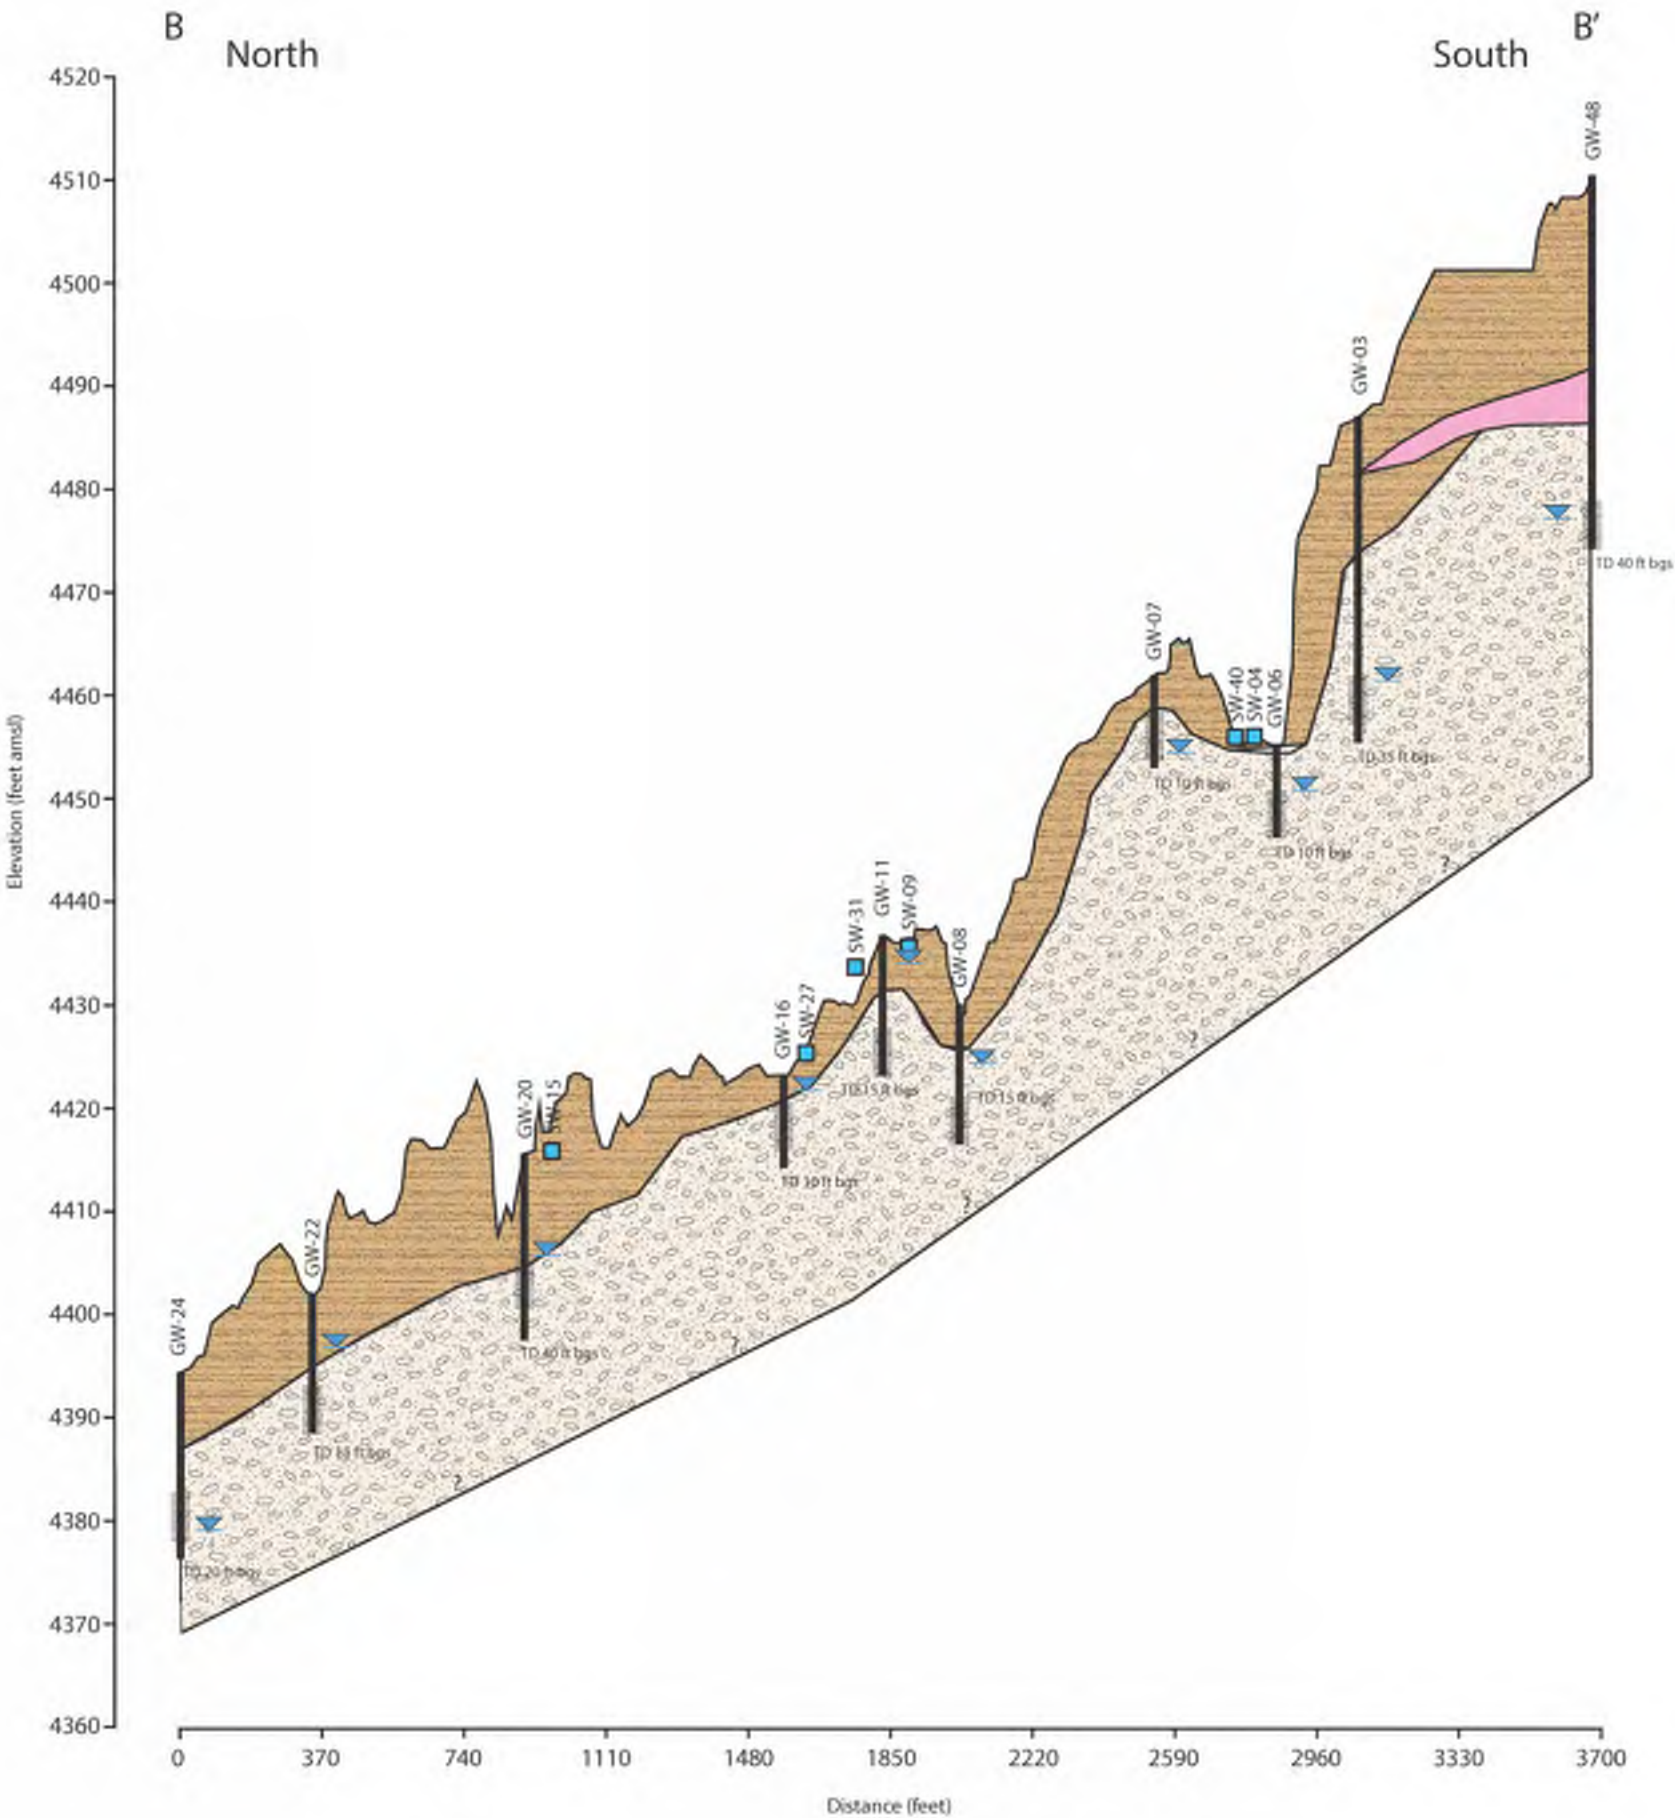
FIGURE 4-4 EAST SIDE SPRINGS SHALLOW CROSS SECTION  
700 South 1600 East PCE Plume, AOU-1: East Side Springs  
Remedial Investigation Report  
Salt Lake City, Utah

Data collected from March 2016 to September 2016  
(Section 6 Tables 6-16 to 6-18)

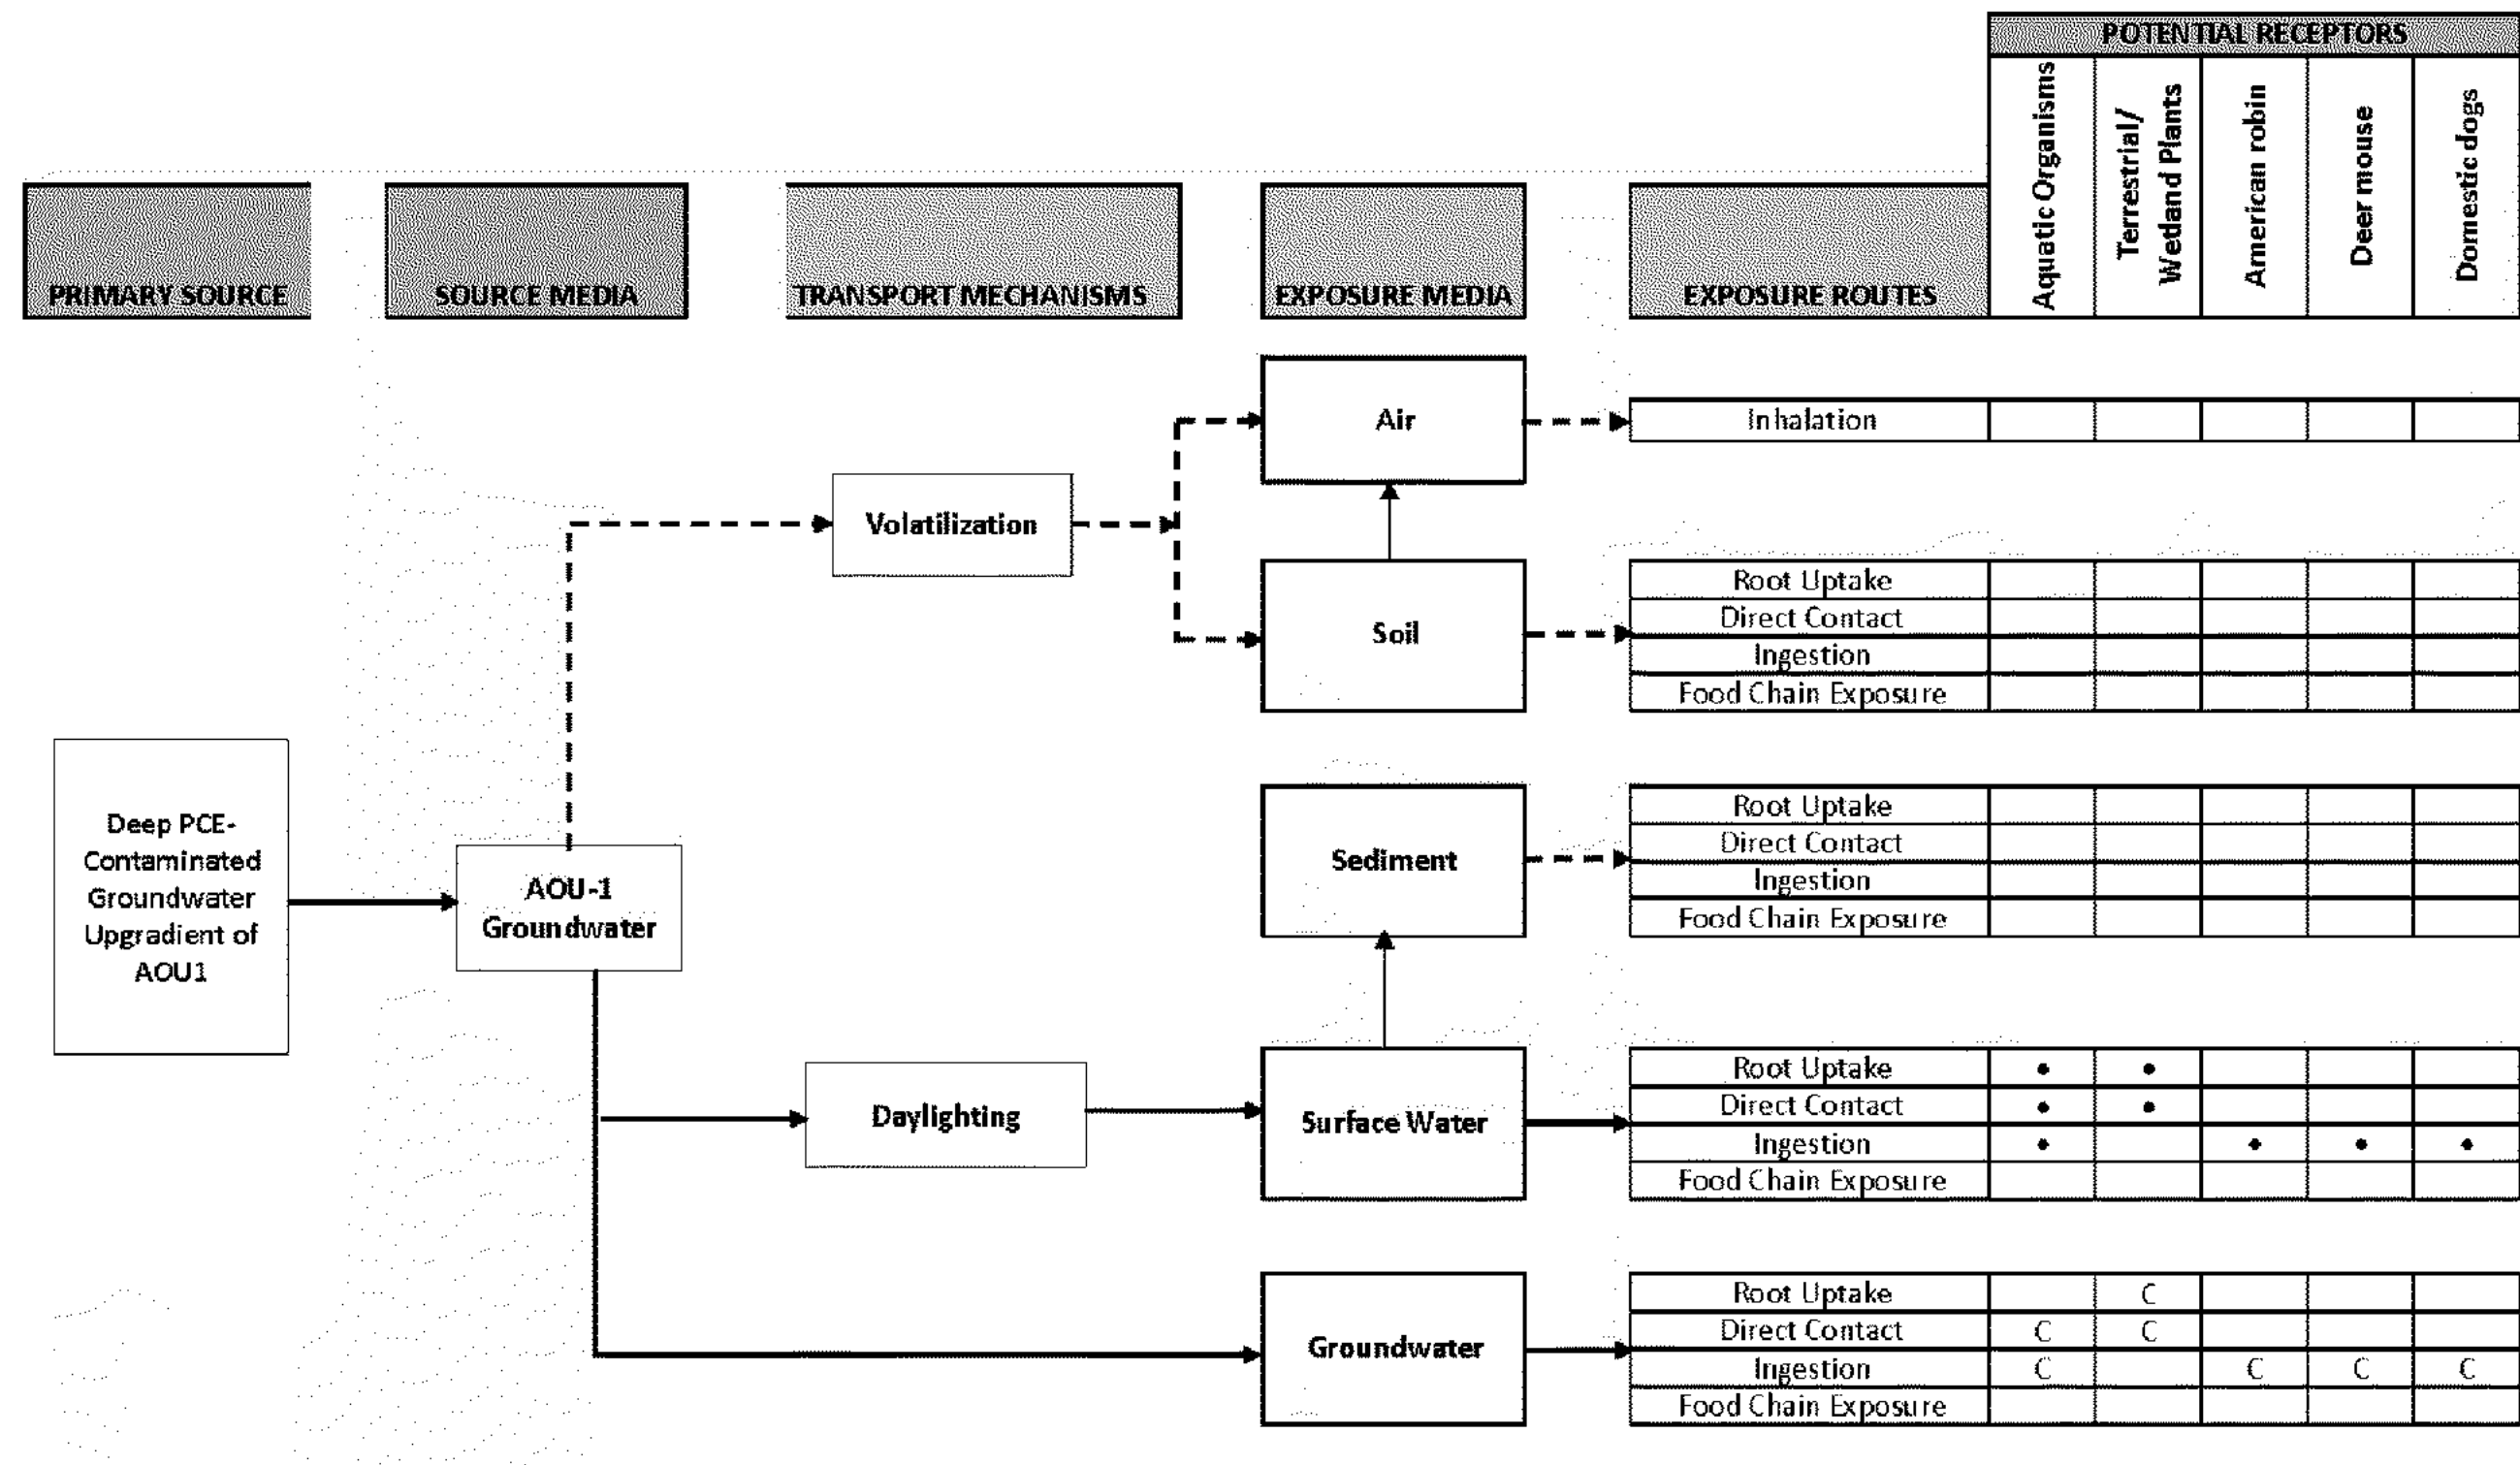
File: Albuquerque EA \\lovetongis\GISdata\Federal\West\Utah\SaltLakeCity\_VeteransAffairs\MXD\RI\_Report\Figure 9-2 Ecological conceptual site model.mxd bprawling 6/5/2018 2:34:25 PM

- Incomplete exposure pathway
- .-.- Potentially complete but minor exposure pathway
- Potentially complete exposure pathway evaluated quantitatively
- Exposure route quantitatively evaluated assuming potential migration of groundwater to surface water
- C Exposure route quantitatively evaluated to be conservative.
